# **Mobile Pentium® II Processor Specification Update**

Release Date: June 1999

Order Number: 243887-011

The Mobile Pentium® II processor or the Intel® Pentium® II Processor Mobile Module may contain design defects or errors known as errata which may cause the product to deviate from published specifications. Current characterized errata are documented in this Specification Update.

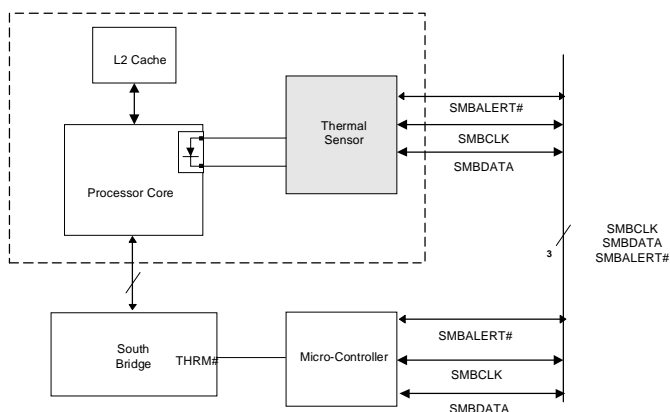
**Figure 1. An Example of Microcontroller Driven Thermal Management**

## **B30. Thermal Sensor May Assert SMBALERT# Incorrectly**

**PROBLEM:** The Mobile Pentium II processor and the Pentium II Processor Mobile Module have a thermal sensor that monitors the processor core's temperature. Please note that desktop systems could have a similar thermal device. The thermal sensor asserts SMBALERT# if the processor temperature exceeds the temperature limits set in the Alarm Threshold Registers (T<sub>HIGH</sub>, T<sub>LOW</sub>). It also sets the corresponding Status Register bits to identify the cause of the interrupt. Figure 1 gives one example of the how the SMBALERT# signal could be used in a system.

Under the conditions described below, the thermal sensor incorrectly generates the SMBALERT# interrupt. *All* of the following conditions must be met to trigger a false interrupt:

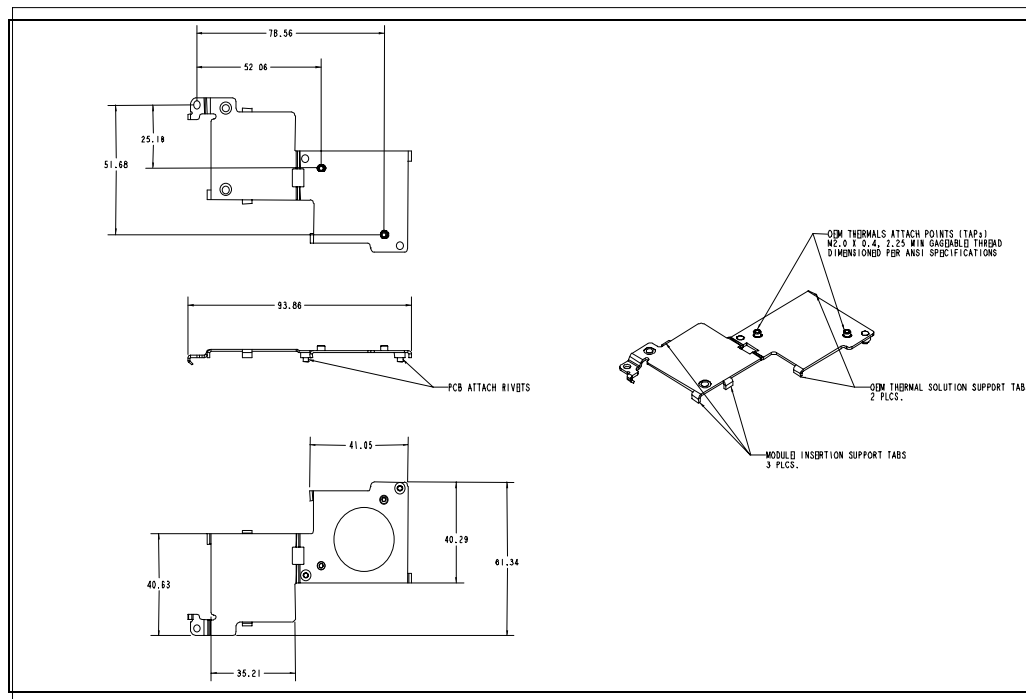
Figure 1. TAP Gageable Thread Clarification

OEM Thermal Attach Points (TAPs) M2.0 x 0.4, 2.25 min gageable thread dimensioned per ANSI specification.

See Figure 1 below for more information.
